# BIGHORN BACKCOUNTRY REPORT

Results of the 15 years of research  
and monitoring of trails in the Bighorn

Devon Earl, Conservation Specialist

Alberta Wilderness Association

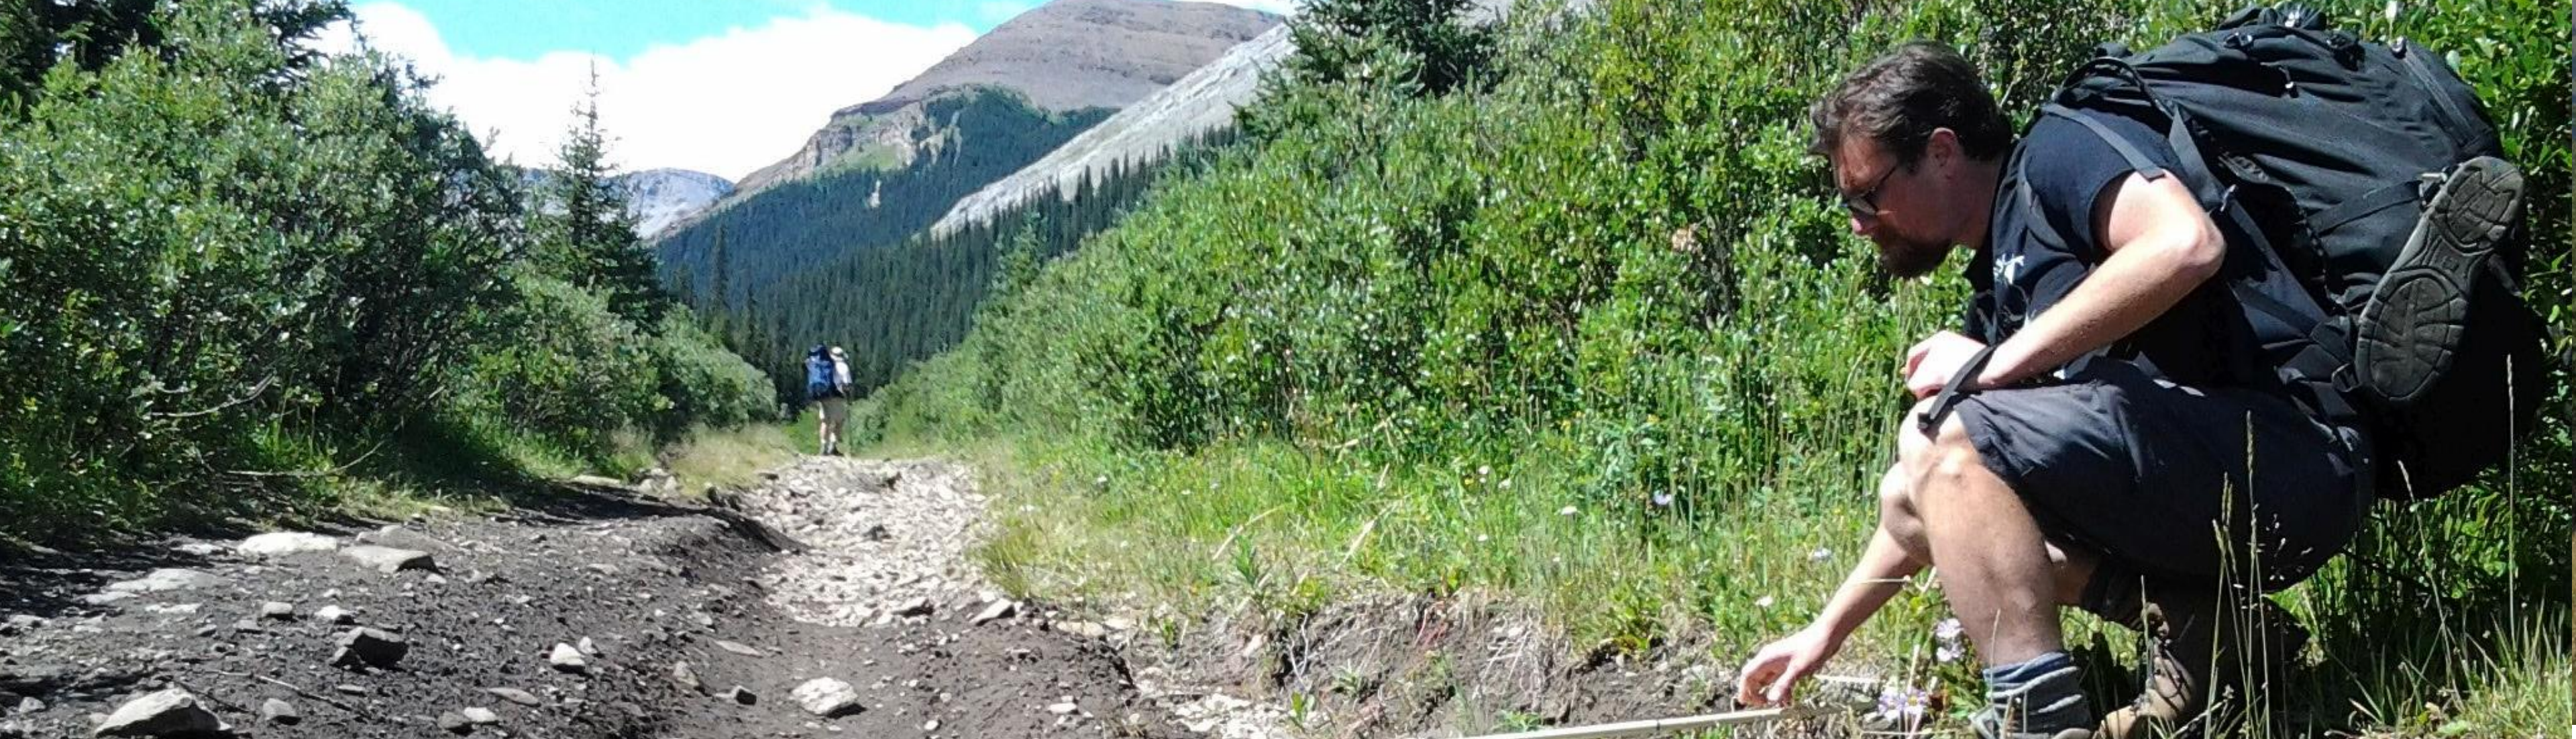
# TRAIL MONITORING

- **Trail Damage Observations** – erosion, trail braiding, vegetative damage, off-trail use, crossings, campsites. GPS location, measurements of damage, photographs.
- **Vehicle Traffic Counts** – TRAFx vehicle counters were embedded in the trail at eight strategic spots in the network.

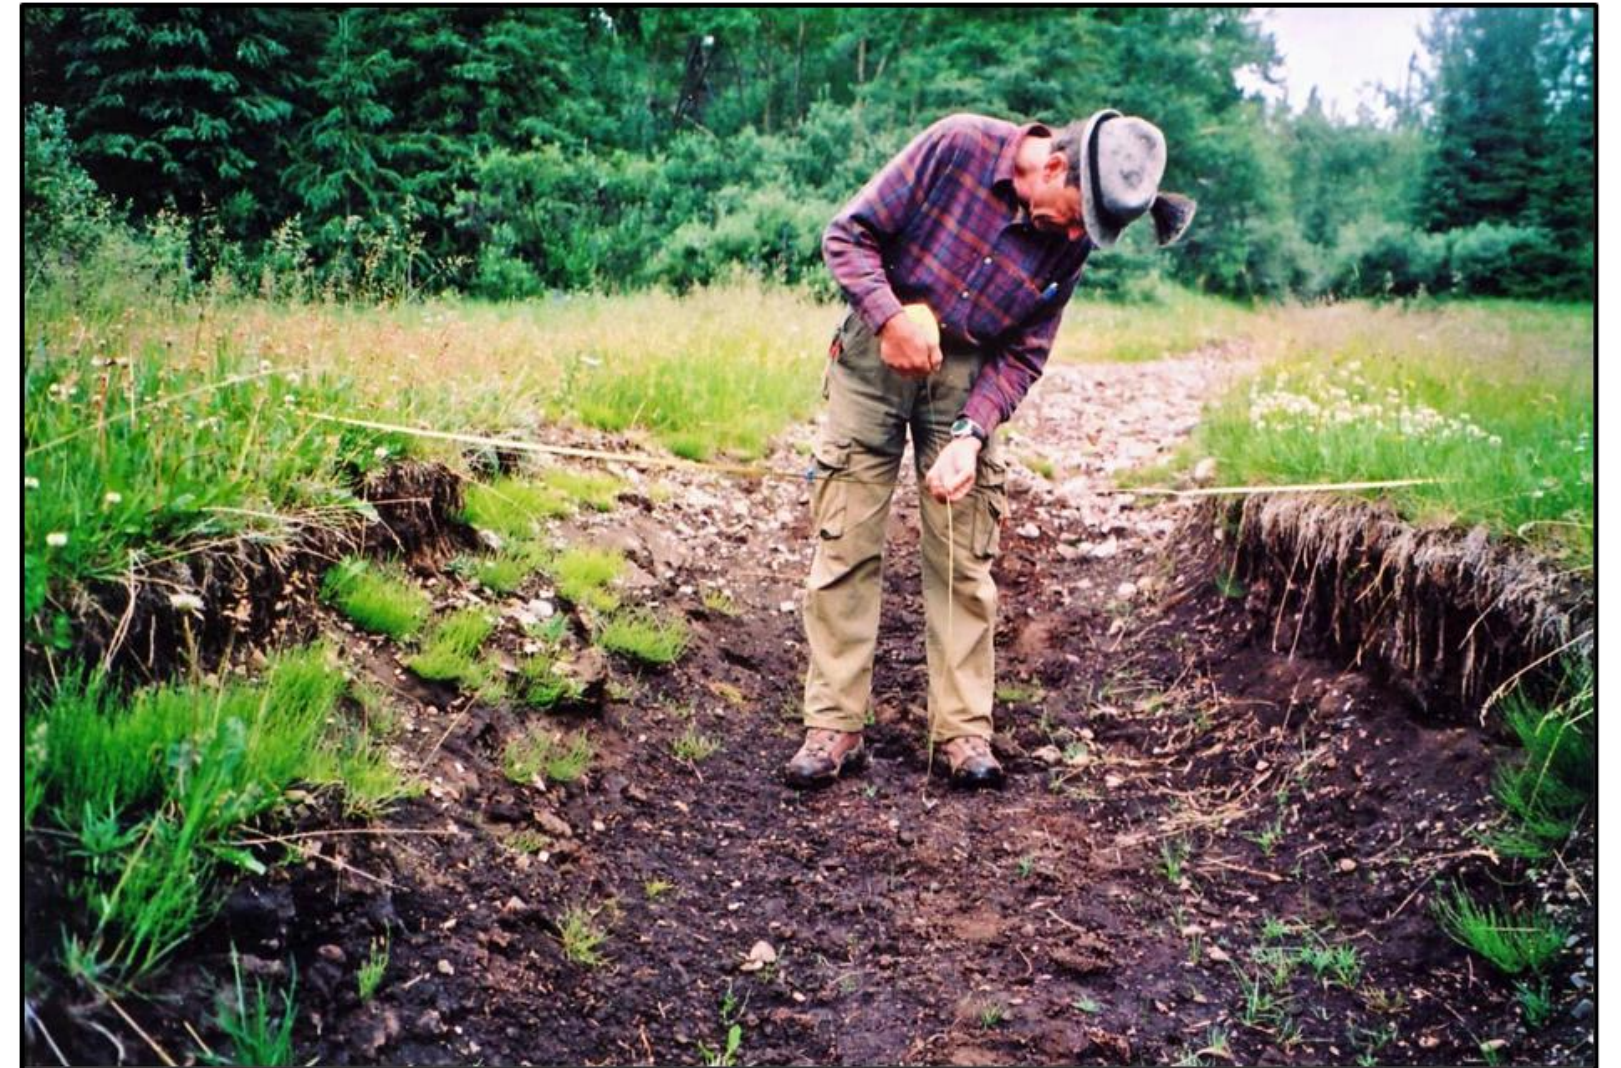
# DAMAGE SITES

**Damage site:** Part of a designated trail where rutted depth exceeded 5 cm and where vegetation damage exceeded a width of 3 m (except where historic roads resulted in trails already exceeding 3 m width).

**Erosion Event:** Sites are identified as an erosion event when rut depth is deeper than 25 cm for three meters or more. These were classified by type of tracks present: motorized, equestrian, or mixed.

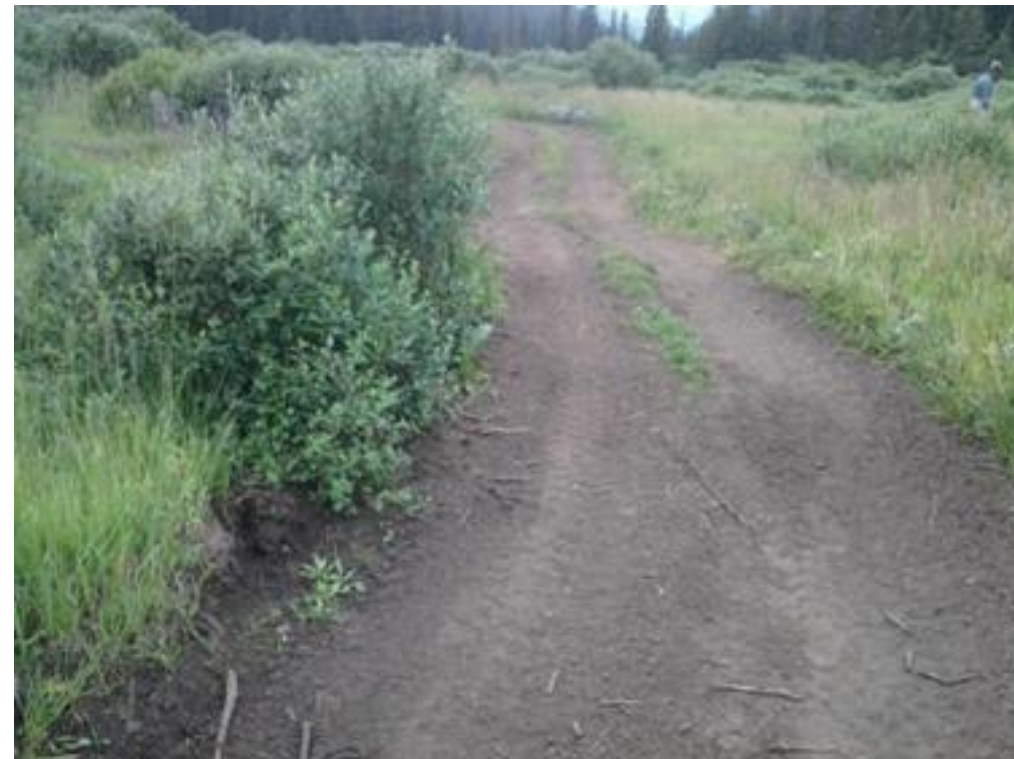
CAN damage site  
Taken 2014-08-12  
Severity: 2  
L: 40m, W: 3m, D: 40cm

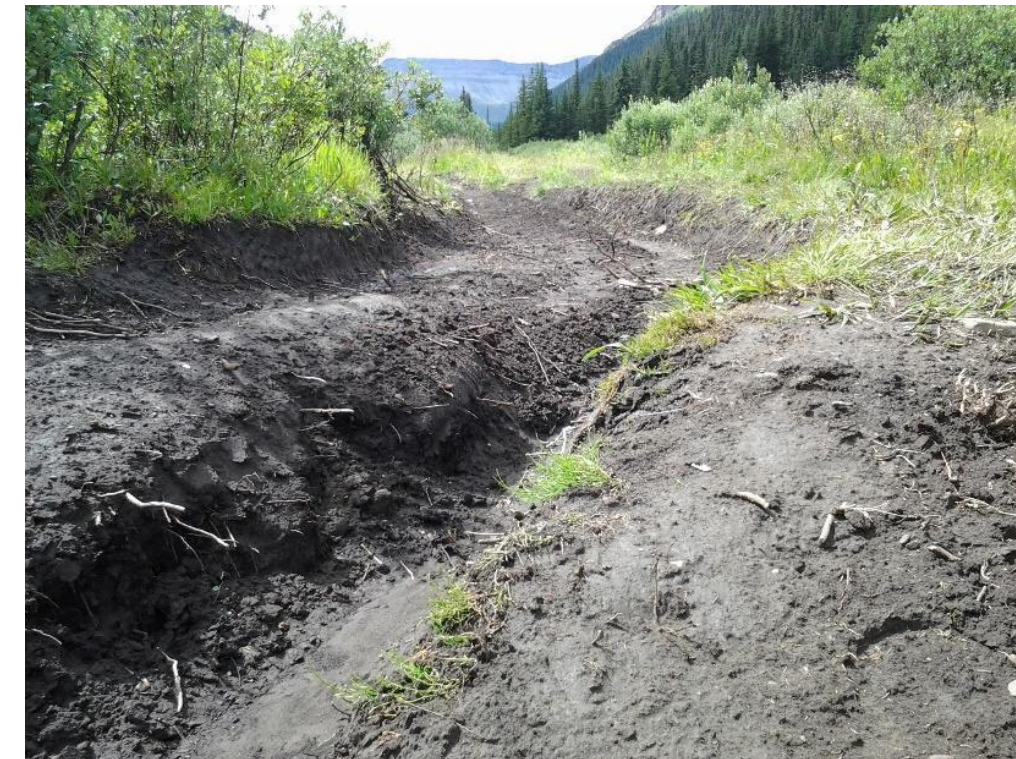
CAN damage site  
Taken 2017-07-24  
Severity: 5  
L: 72m, W: 3m, D: 55cm

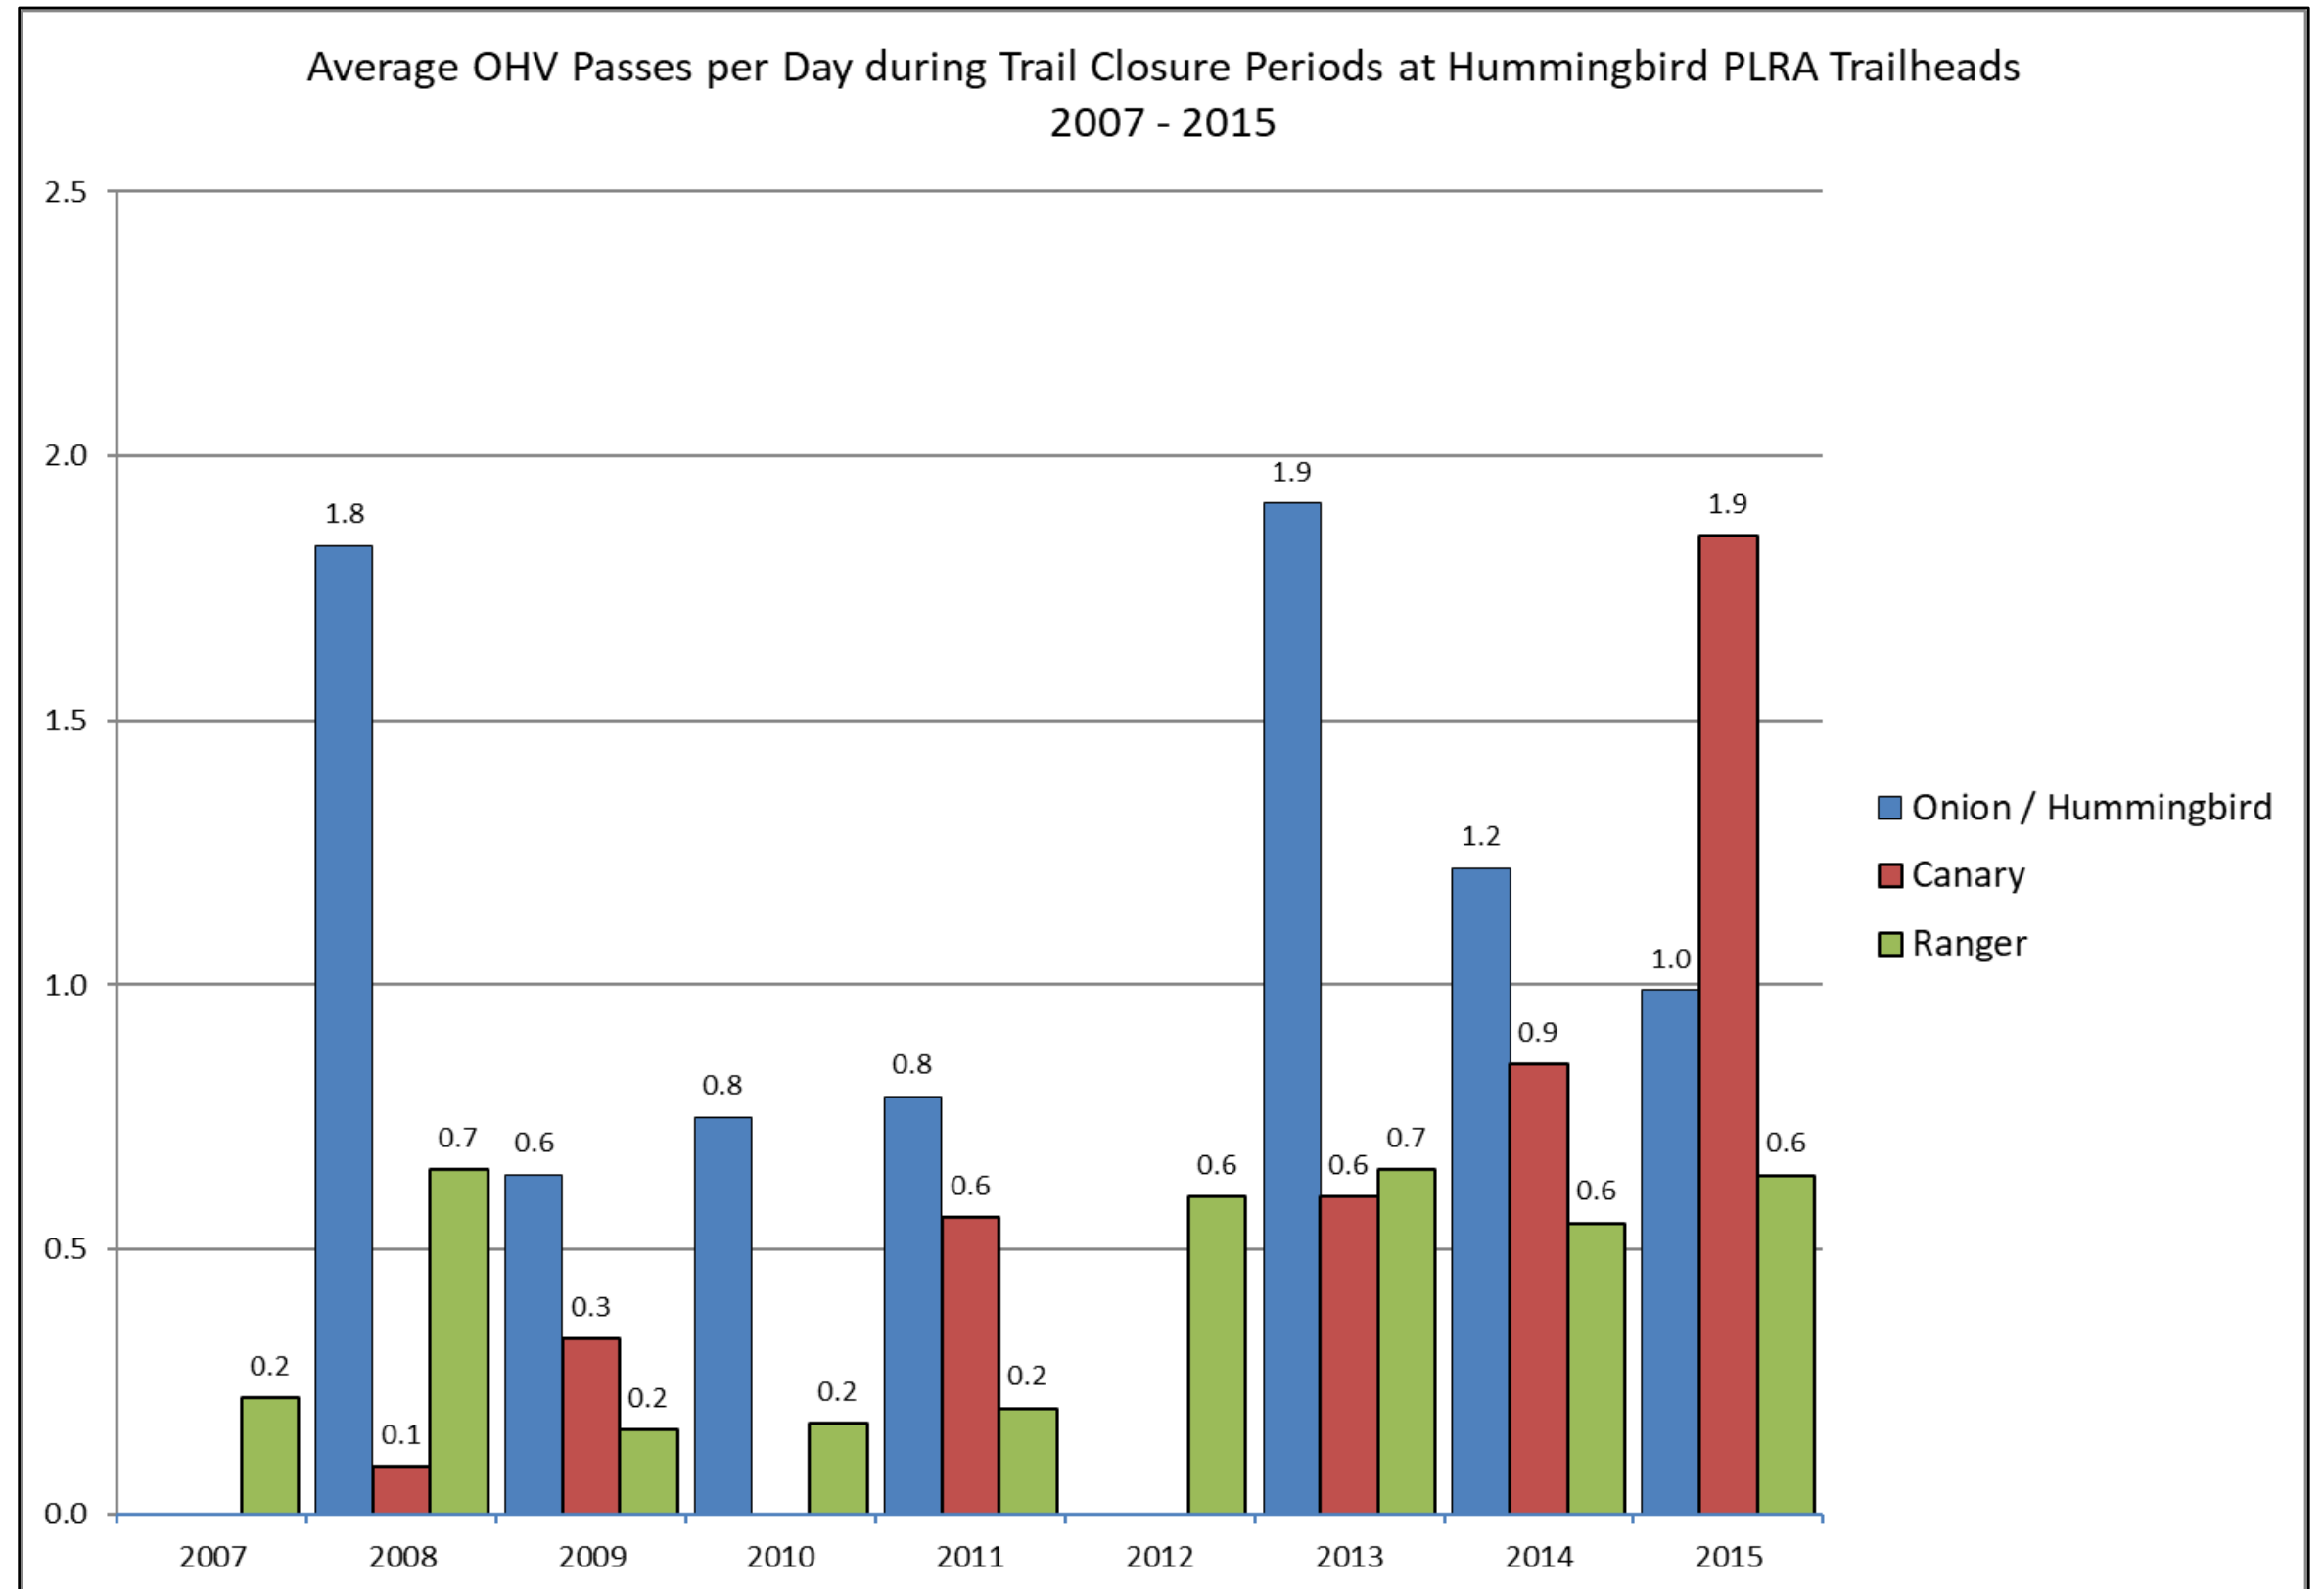
# TRAIL USE DURING CLOSURES

Illegal use of the trail network (defined as vehicle passes during closure periods) continues and is significant. Trail closures need to be accompanied by active enforcement.
