Alberta
TRANSPORTATION
Engineering Division

DWG. No	CB - 6 5.15.M6
Date	
Original	Dec. 1978
Revised

**LOCK SEAM
ON HELICALLY FABRICATED
CORRUGATED STEEL PIPE**

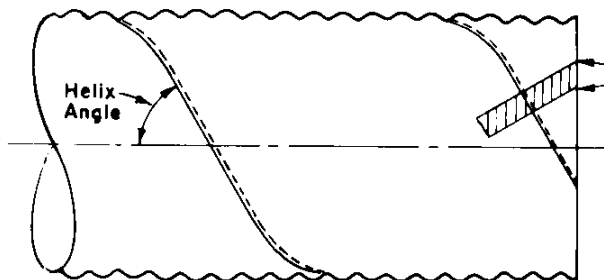
EXAMPLES OF UNACCEPTABLE LOCK SEAM CONSTRUCTION

CROSS - SECTION
of
LOCK SEAM

INTERIOR ANGULARITY

INTERIOR ANGULARITY
and
ROLLER INDENTATION

LACK OF CONTACT ON LAPPED
SURFACES, IMPROPER RETAINING
OFFSET LOCATION

INSUFFICIENT RETAINING OFFSET

ROLLER INDENTATION, INTERIOR ANGULARITY, LACK
OF TIGHT CONTACT ON LAPPED SURFACES

TYPICAL SAW CUTS FOR
SAMPLING LOCK SEAM
(TAKEN AT RANDOM)
